# FIELD INSPECTION REPORT

<b>Project Name:</b>	Mountain Valley Pipeline	<b>Inspector:</b>	Matthew Grant
<b>Inspection Date:</b>	Wednesday, March 3, 2021	<b>Project Contact:</b>	Brian Clauto
<b>Spread I: Franklin</b>	ST14390+76-14425+00 ST14010-13950 ATWS 1466, 622 AR-FR 306.03, 306.02	<b>Weather:</b>	Wet

## FIELD INSPECTION PHOTO LOG

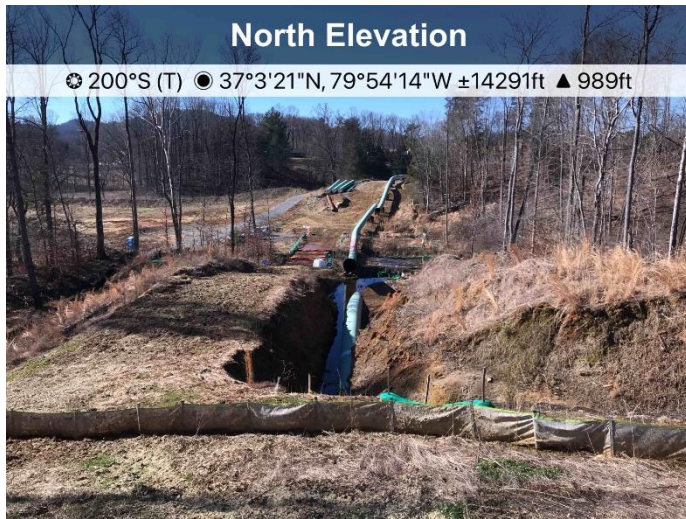
- Figure 1: Near St14000 ECD's are in place and the area has recently been stabilized with hydro mulch.

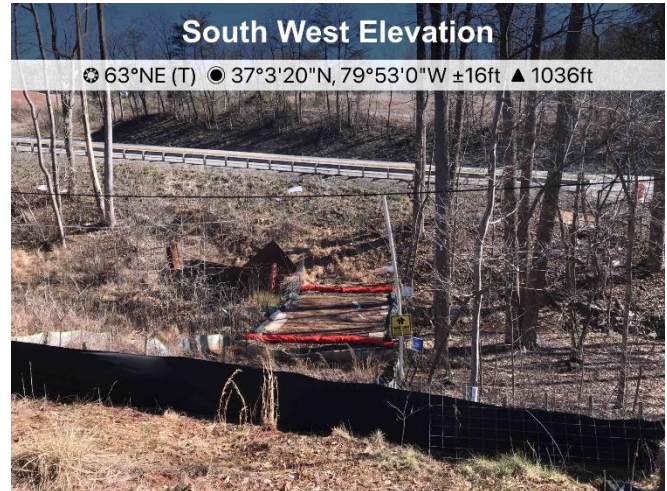
- Figure 2: Designated stream crossing SKL38, ECD's are in place and functioning.

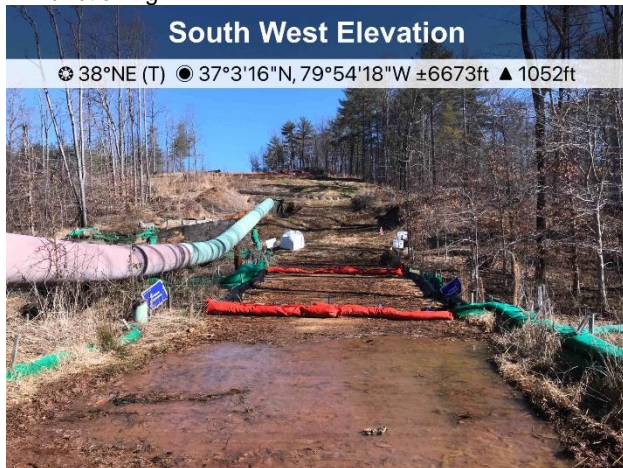
- Figure 3: Designated stream crossing S-36, ECD's are in place and functioning.

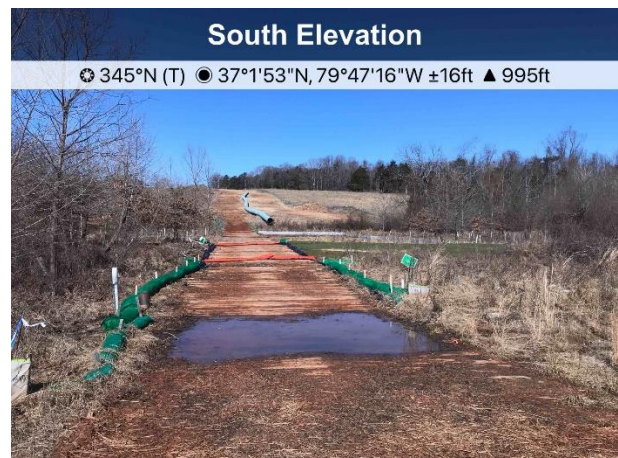
- Figure 4: Designated crossings S-A41, ECD's are in place and functioning.
